DEPARTMENT OF TRANSPORTATION

WELDING INSPECTION REPORT

OSM Arrival Time: 700 **Project Name:** SAS Superstructure **OSM Departure Time:** 1700 **Prime Contractor:** American Bridge/Fluor Enterprises, a JV

34-0006 **Bridge No: Component: OBG** and Tower

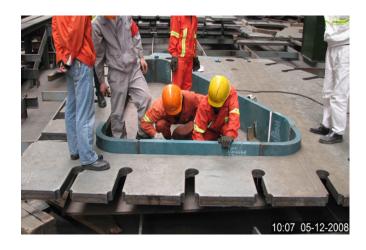
The Quality Assurance Inspector observed 5 sets of diaphragm flanges in various stages of fabrication from fit-up to in process welding. The Quality Assurance Inspector performed a random inspection of the fit-up of one of the diaphragm flanges. ABF was notified of various discrepancies in the bevel preparation. Below are two digital photographs illustrating the discrepancies.
